Pacific West Home Inspections

Report Index

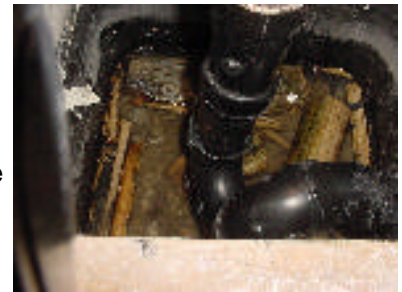
[FE] There upstairs plumbing leaks at the shower and the living room ceiling and walls were damage. There is a concern that the contractor did not open up the walls and ceiling so that those areas could dry out. There were signs of black microbial substance at the bottom of the wall. There was also standing water under the tub at the 1st level bath. We recommend that the drywall be removed in the damaged areas and have an Industrial Hygienist evaluate and sample for mold.

[FE] The builded failed to connect the drain lines at tub fixture at the first floor hall bath, there were drain leaks at the shower at the master bath and a leaking solder joint at the water supply line at the toilet feature at the master bath. The two fixtures probems at the 2nd level and first floor tub fixture leaked into the interior walls and ceiling at the first level living room. There was standing water under the tub at the first level hall bath. We recommend that the drywall be removed from the walls and ceiling at the affected areas and let the cavities dry out. We also recommend that the house be further evaluated by an Industrial Hygienist for mold. Wait for the mold reports before replace the drywall. (Additional photos at the end of report.)

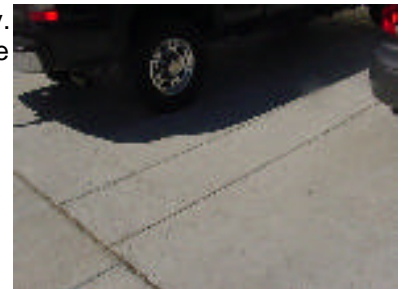
216 SITE GRADING	[RU] We recommend to upgrade and install under ground drainage system.
217 DRIVEWAY(S)	[CR] Damage surface sections at the driveway. We recommend that a qualified specialist in the appropriate trade correct the condition(s) noted.

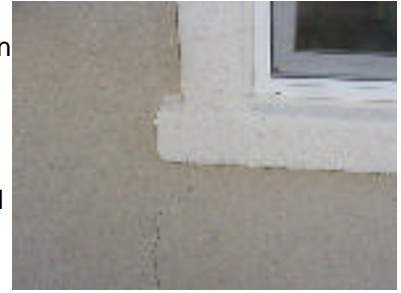
230 STUCCO CLADDING

[CR] There were cracks the stucco siding. One of the cracks migrates through the plant-on window detail at the rear of house. These conditions may be conducive to moisture intrusion/deterioration. We recommend a full evaluation and/or corrections by a specialist in the appropriate trade. If the cracks are repaired then we also recommend that the stucco be fogged coated at the exterior of the house to keep a uniform color to the house.

Please see the series of photos at the end of report. The photos were taken on 03/06/2004 and 03/30/2004 In my opinion the cracks are getting worse.

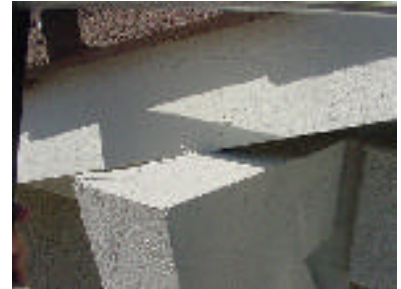
242 FASCIA(S)

[CR] Water flows back to the house at the the front protruding beams details at the front exterior of the garage. We recommend that a qualified specialist correct the condition(s) noted.

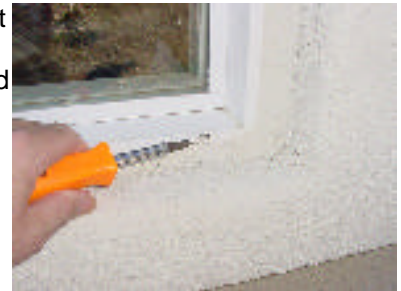
246 WINDOW(S)

[CR] The drain slots were covered by stucco at a number of windows. The window tracks had debris at many of the windows. We recommend that a qualified specialist in the appropriate trade correct the condition(s) noted.

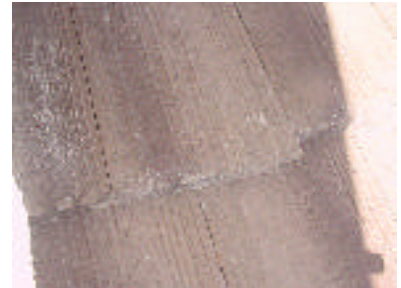
309 **CONCRETE
TILES**

[FE] There were a number of unsecured, displaced or improperly fastened tiles the top row at the garage roof to house wall. The underlayment felt was exposed to the weather. These conditions are conducive to roof leaks. We recommend a full evaluation and/or corrections by a specialist in the appropriate trade.

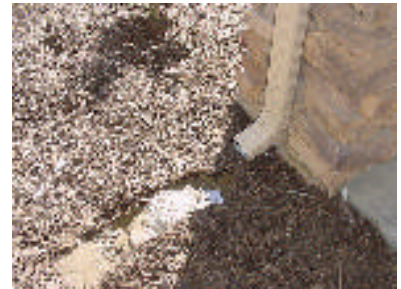
DOWNSPOUT(S)

[CR] Runoff water from the roof discharged next to the building. We recommend the downspouts be routed sufficiently away from the building to prevent ponding, pooling, and saturation of the soil at the foundation.

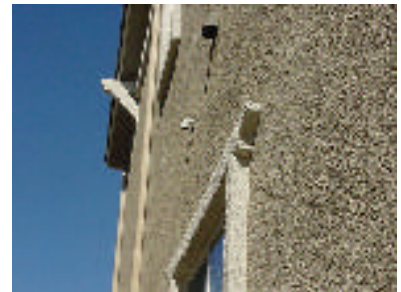
509 WASTE PIPING

[CR] The exterior outlet for the laundry room floor drain does not extend out further than the window detail plant-on at the left side of house. We recommend that a qualified specilist make the recommended repairs.

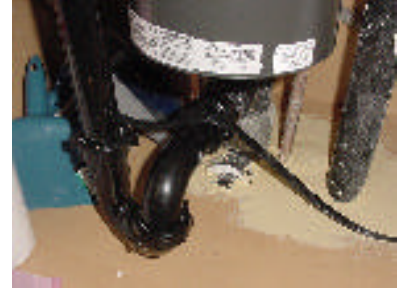
512 SINK(S)

[CR] The island sink cleanout was partially covered over by the base of the island. The cleanout could not be accessed. We recommend that a qualified specialist in the appropriate trade correct the condition(s) noted.

[CR] There was a gap at the sink lip at the tile counter at the kitchen. We recommend that a qualified specialist in the appropriate trade correct the condition(s) noted.

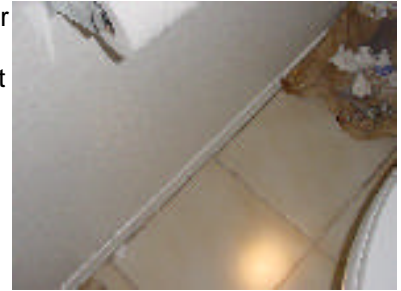
513 TOILET(S)

[FE] There was moisture at the floor tiles near the toilet at the master bath. We recommend a full evaluation and/or corrections by a specialist in the appropriate trade.

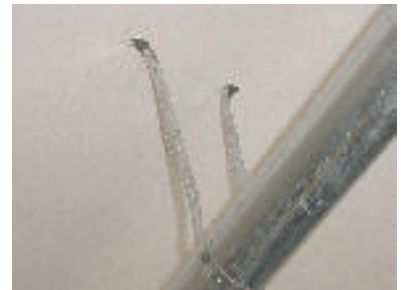
531 VENTING
SYSTEM(S)

[CR] Dry wall screws were used to secure the holding straps. Wrong type of screw used. We recommend that a qualified specialist correct the condition(s) noted.

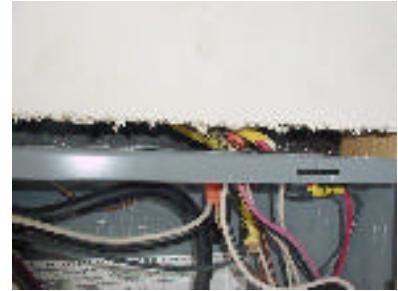
616 WORKMANSHIP

[SC] There were exposed wires above the subpanel. We recommend that a qualified specialist in the appropriate trade correct the condition(s) noted.

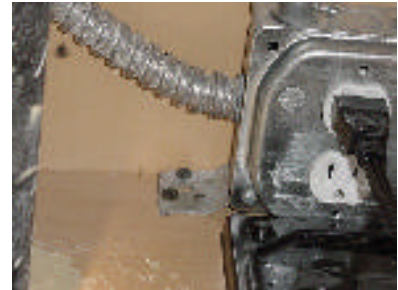
622 BRANCH WIRING

[CR] The junction box was secured by drywall screws under the kitchen island sink. Drywall screws are not listed for this application.

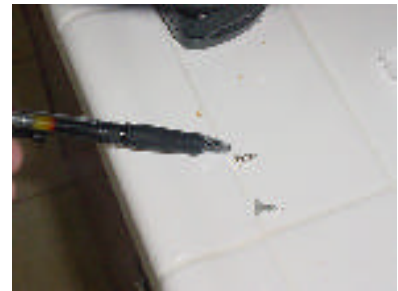
626 RECEPTACLE(S)

[CR] Improper type of screws were used to mount the face plate at the receptacle at the side of the island.

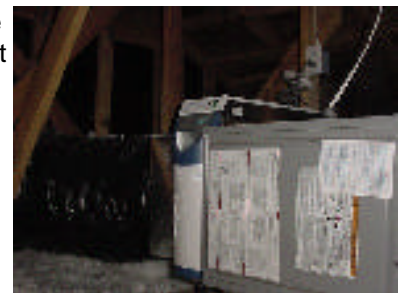
711 **BLOWER / FILTER(S)** [CR] The electronic filter was inoperable at the attic. We recommend that a qualified specialist in the appropriate trade correct the condition(s) noted.

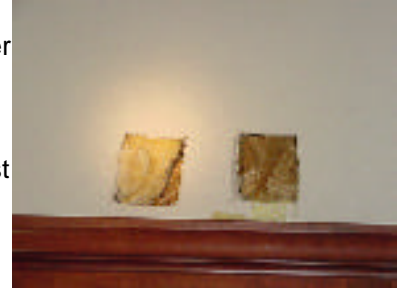
1007 WALL(S)/ CEILING(S)

[CR] There were cutout section of drywall at several walls. The buyers stated that the builder installed phone lines did not work and the builder's subcontractors is locating the wires in the wall cavities. Correct the phone lines and walls. We recommend that a qualified specialist in the appropriate trade correct the condition(s) noted.

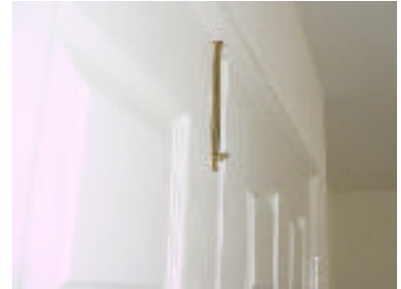
1017 INTERIOR DOOR(S)

[CR] The double doors did not shut tight at the master bedroom. We recommend that a qualified specialist in the appropriate trade correct the condition(s) noted.

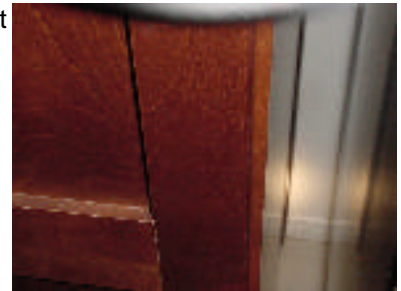
1025 CABINET(S)

[CR] Trim piece was not secured along cabinet opening at refrigerator. We recommend that a qualified specialist correct the condition(s) noted.

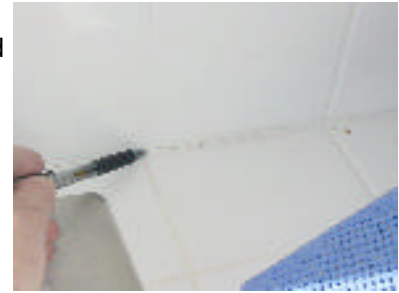
**1026
COUNTERTOP(S)**

[CR] There was a gap at the tile kitchen counter to the tile splash back. We recommend that a qualified specialist in the appropriate trade correct the condition(s) noted.

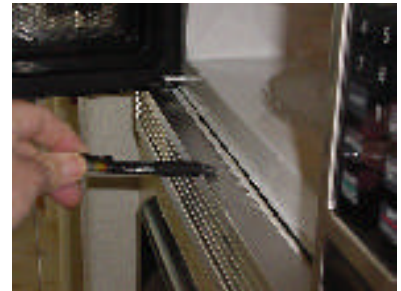
1118
MICROWAVE(S) **[CR]** The microwave was not secured and there was exposed drywall. Reset and secure the microwave.

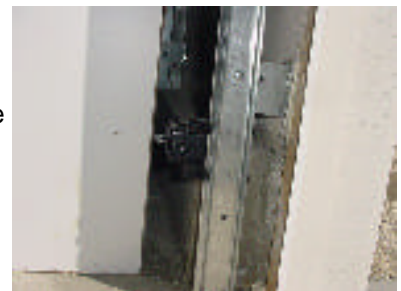
1144 **DOOR OPENER(S)** **[SC]** The secondary safety system (electric eyes) were mounted higher than the manufacturer's recommendation of 4" to 6" above the floor. We recommend correcting the condition(s) noted.

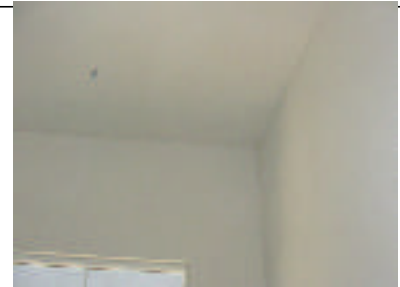
PHOTO # 1: Water stains at ceiling of livingroom.

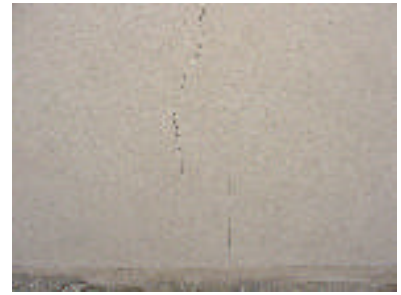
PHOTO # 2:

Cracks at the rear exterior of house.

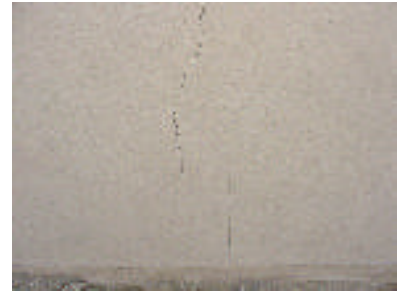
PHOTO # 4:

03/05/2004 Cracks at rear of house.

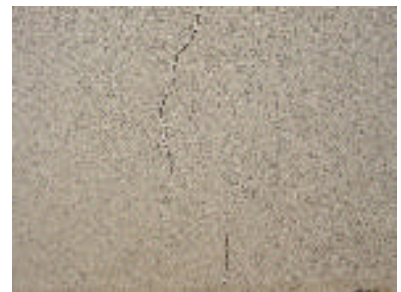
PHOTO # 5:

03/30/2004 Cracks at rear of house.
